**RE: Administrative Order on Consent Submittals  
Waimanalo Gulch Sanitary Landfill**

**RE: Waimanalo Gulch Landfill  
Work Plan for Evaluating Hydraulic Head Below Liner System**

**Subject: Work Plan for Sedimentation Basin Restoration- Waimanalo Gulch  
Sanitary Landfill, Ewa Beach, Oahu, HI (Draft)**

## **Waimanalo Gulch Sanitary Landfill Stormwater Management Update and Contingency Plan 2-1-11**

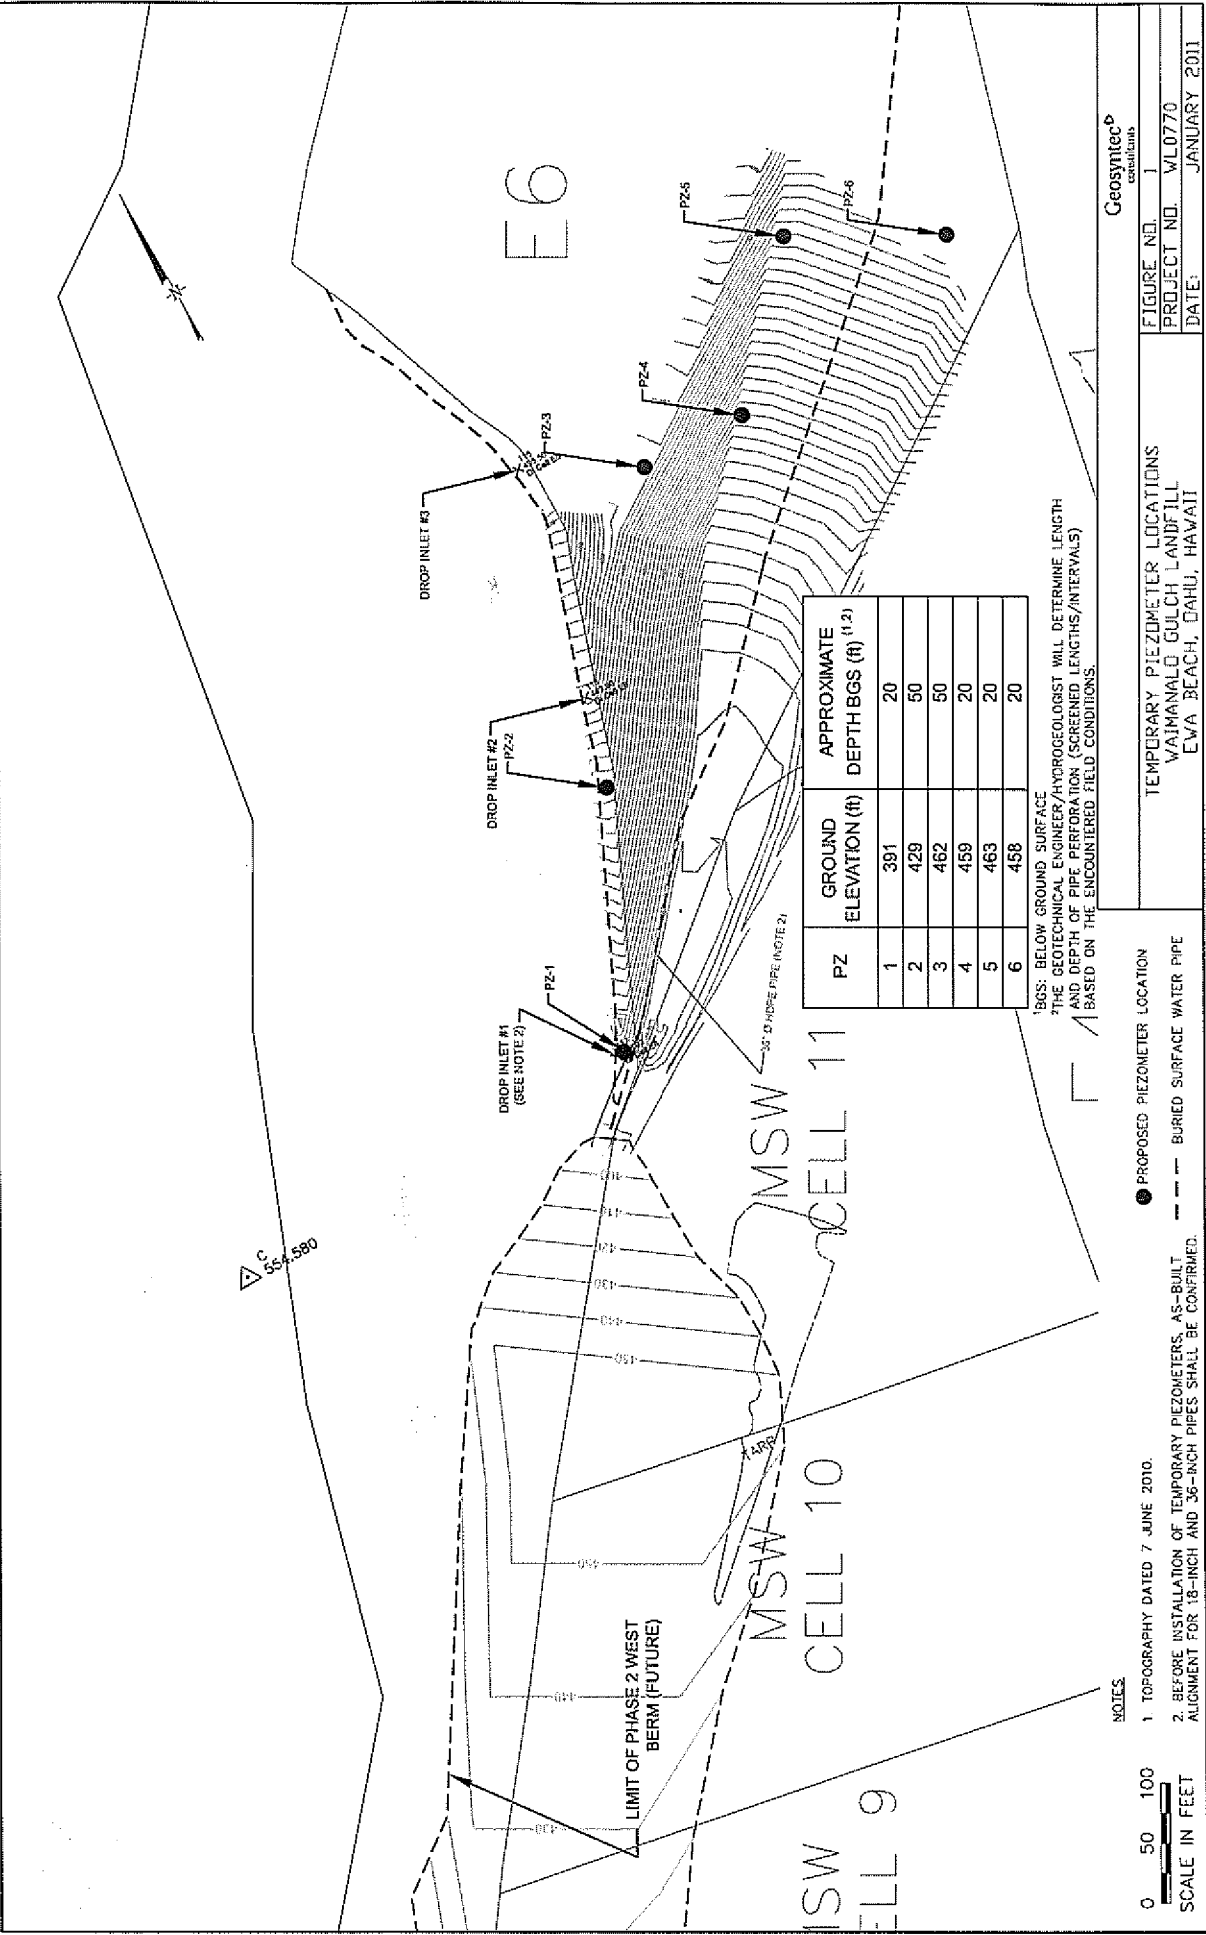
Figure 1 -- Proposed Temporary Piezometer Locations

To evaluate hydraulic head below the liner, the drilling of up to 6 temporary piezometers to various depths below the existing ground surface is proposed. Figure 1 shows the approximate locations of the piezometers and a table with the estimated ground elevation and the estimated drilling depth to reach below the liner level. These drilling depths will need to be confirmed at the time of drilling to verify that the appropriate elevation will be achieved. Piezometer locations may be adjusted in the field as needed with concurrence by the engineer.

As can be observed, the piezometers are located around the perimeter of Cell E6. The locations of the piezometers will need to be located away from buried utilities such as the 18-inch and 36-inch HDPE surface water conveyance pipes. The borings are planned to be outside the lined area except where the liner has been damaged and must be replaced. The as-built locations of the utilities (buried or on the surface) will need to be established before drilling begins.
